Village Creek Assessment Report

Village of Island Lake, Illinois

June 2022

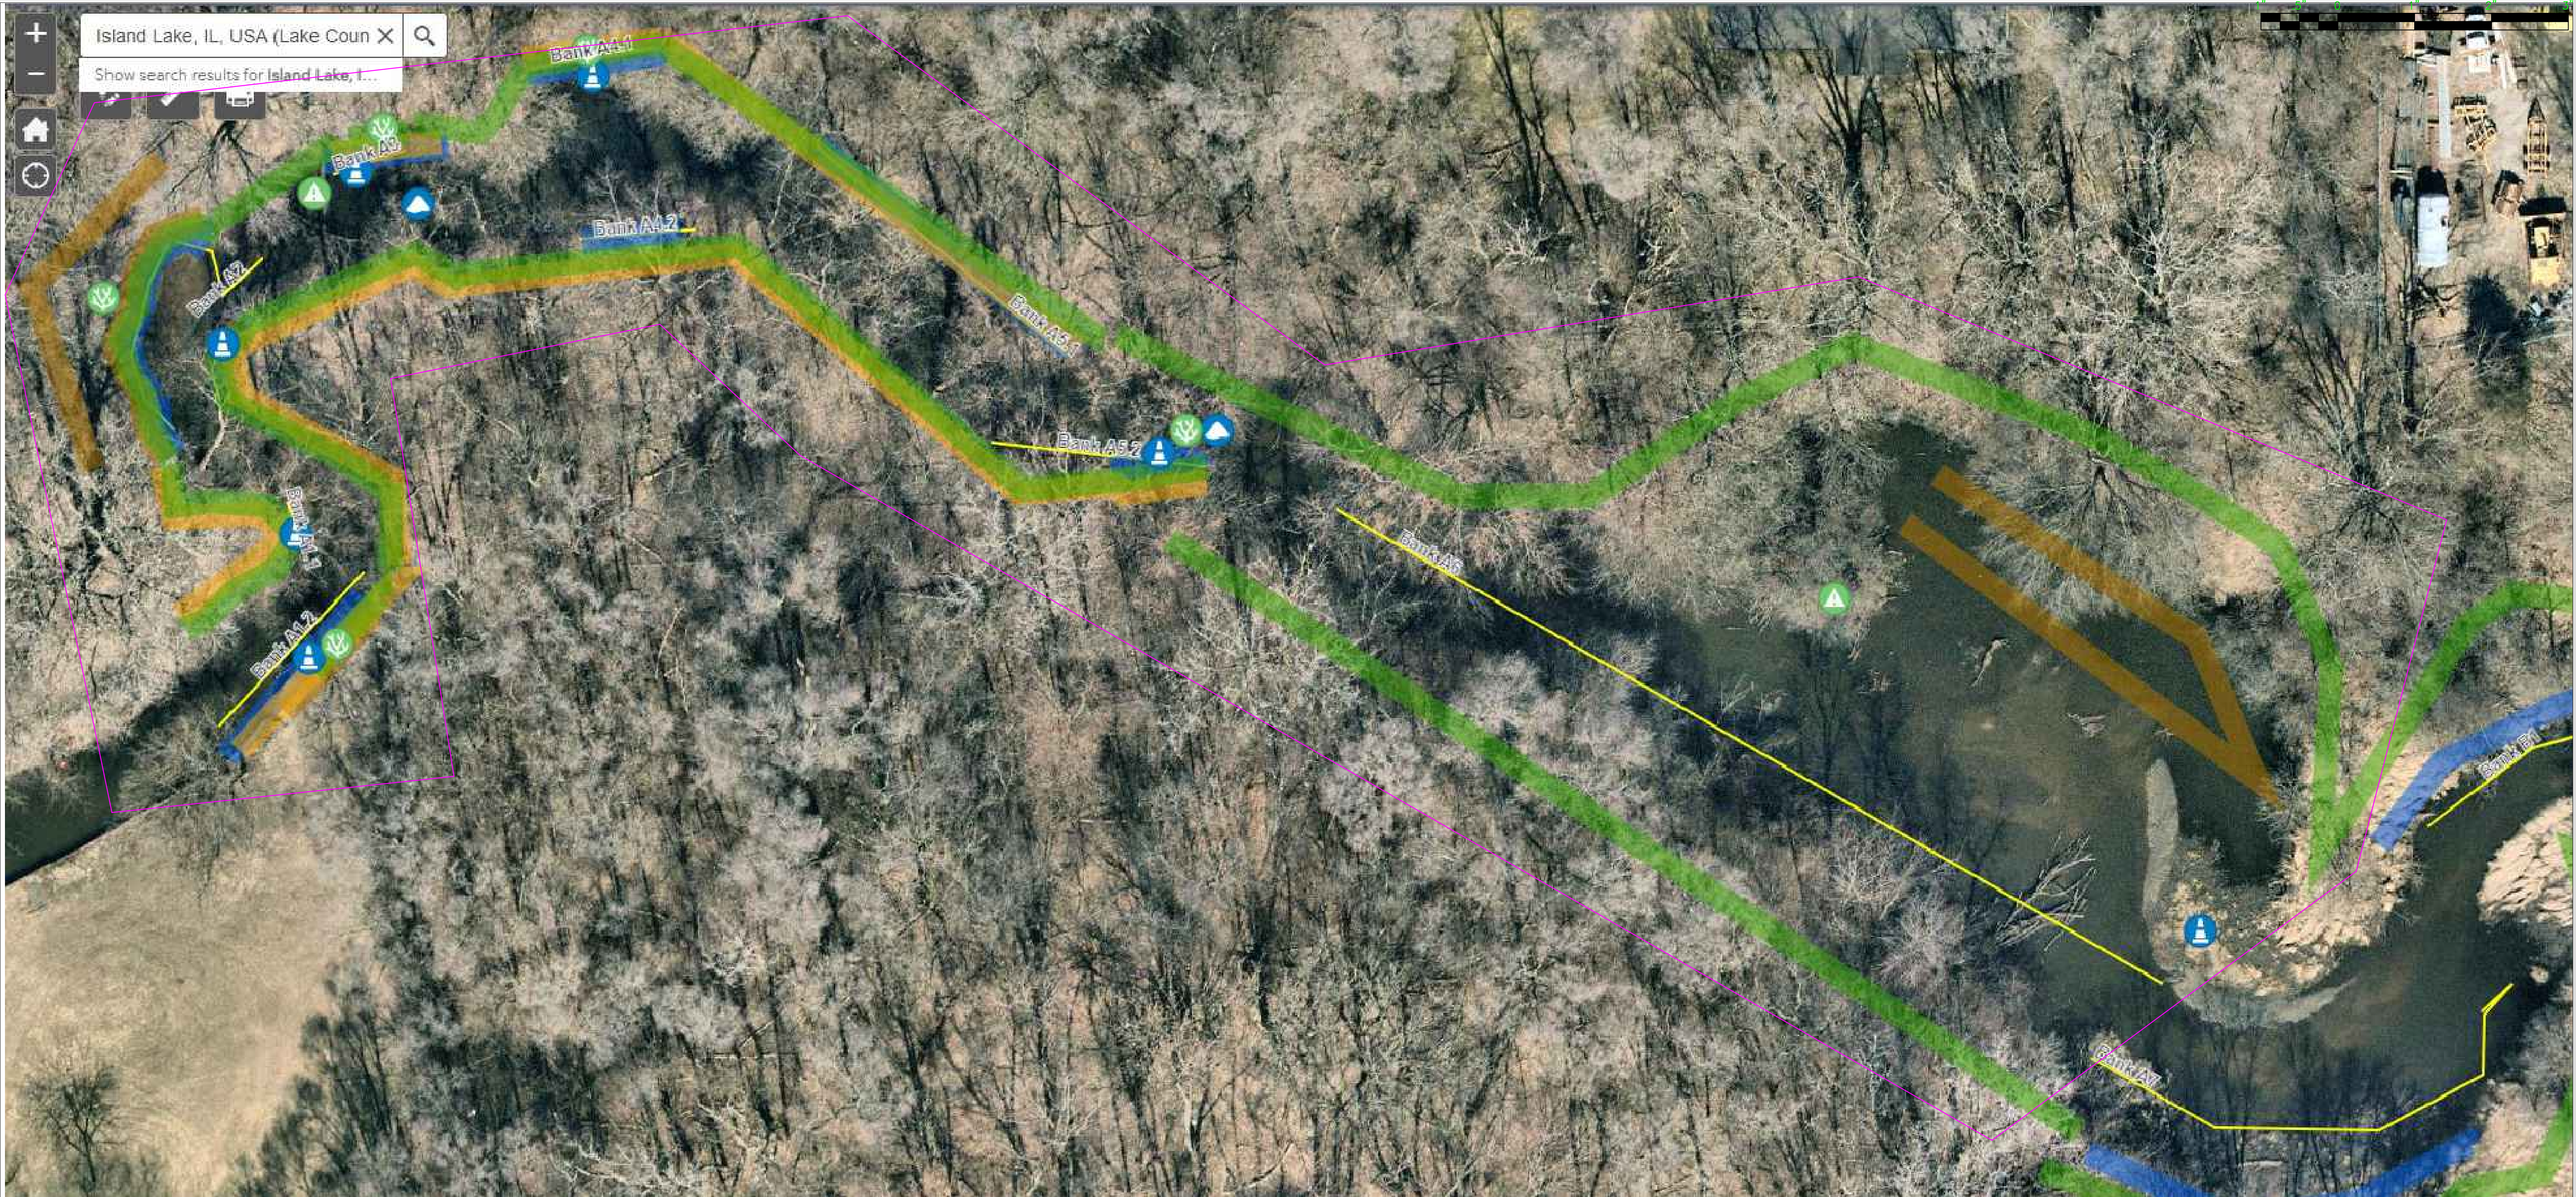
Exhibit A
TOTAL SHEETS
11
SHEET NO.
1

Feet of Bank erosion
A1.1=60ft
A1.2=20ft
A2=80ft
A3=40ft
A4.1=45ft
A4.2=40ft
A5.1=90ft
A5.2=30ft
A6=TBD

Recommended repair work in this section would consist of large regrading and reshaping of the existing banks. Rock armaments would be implemented in areas with higher water flow. Cross veins would be put in areas where the flow needs to be redirected away from the banks. This can solve some erosion problems without the use of large armament walls. Native vegetation will be installed to hold the slopes in place.

All the banks in Section A will require, at the very least, minimal maintenance work to remove nonnative vegetation and debris to allow for better conveyance. Banks A1.1-A7 all require some degree of repair to address the erosion concerns present in each. Most of these are of high priority as they are experiencing a higher degree of erosion.

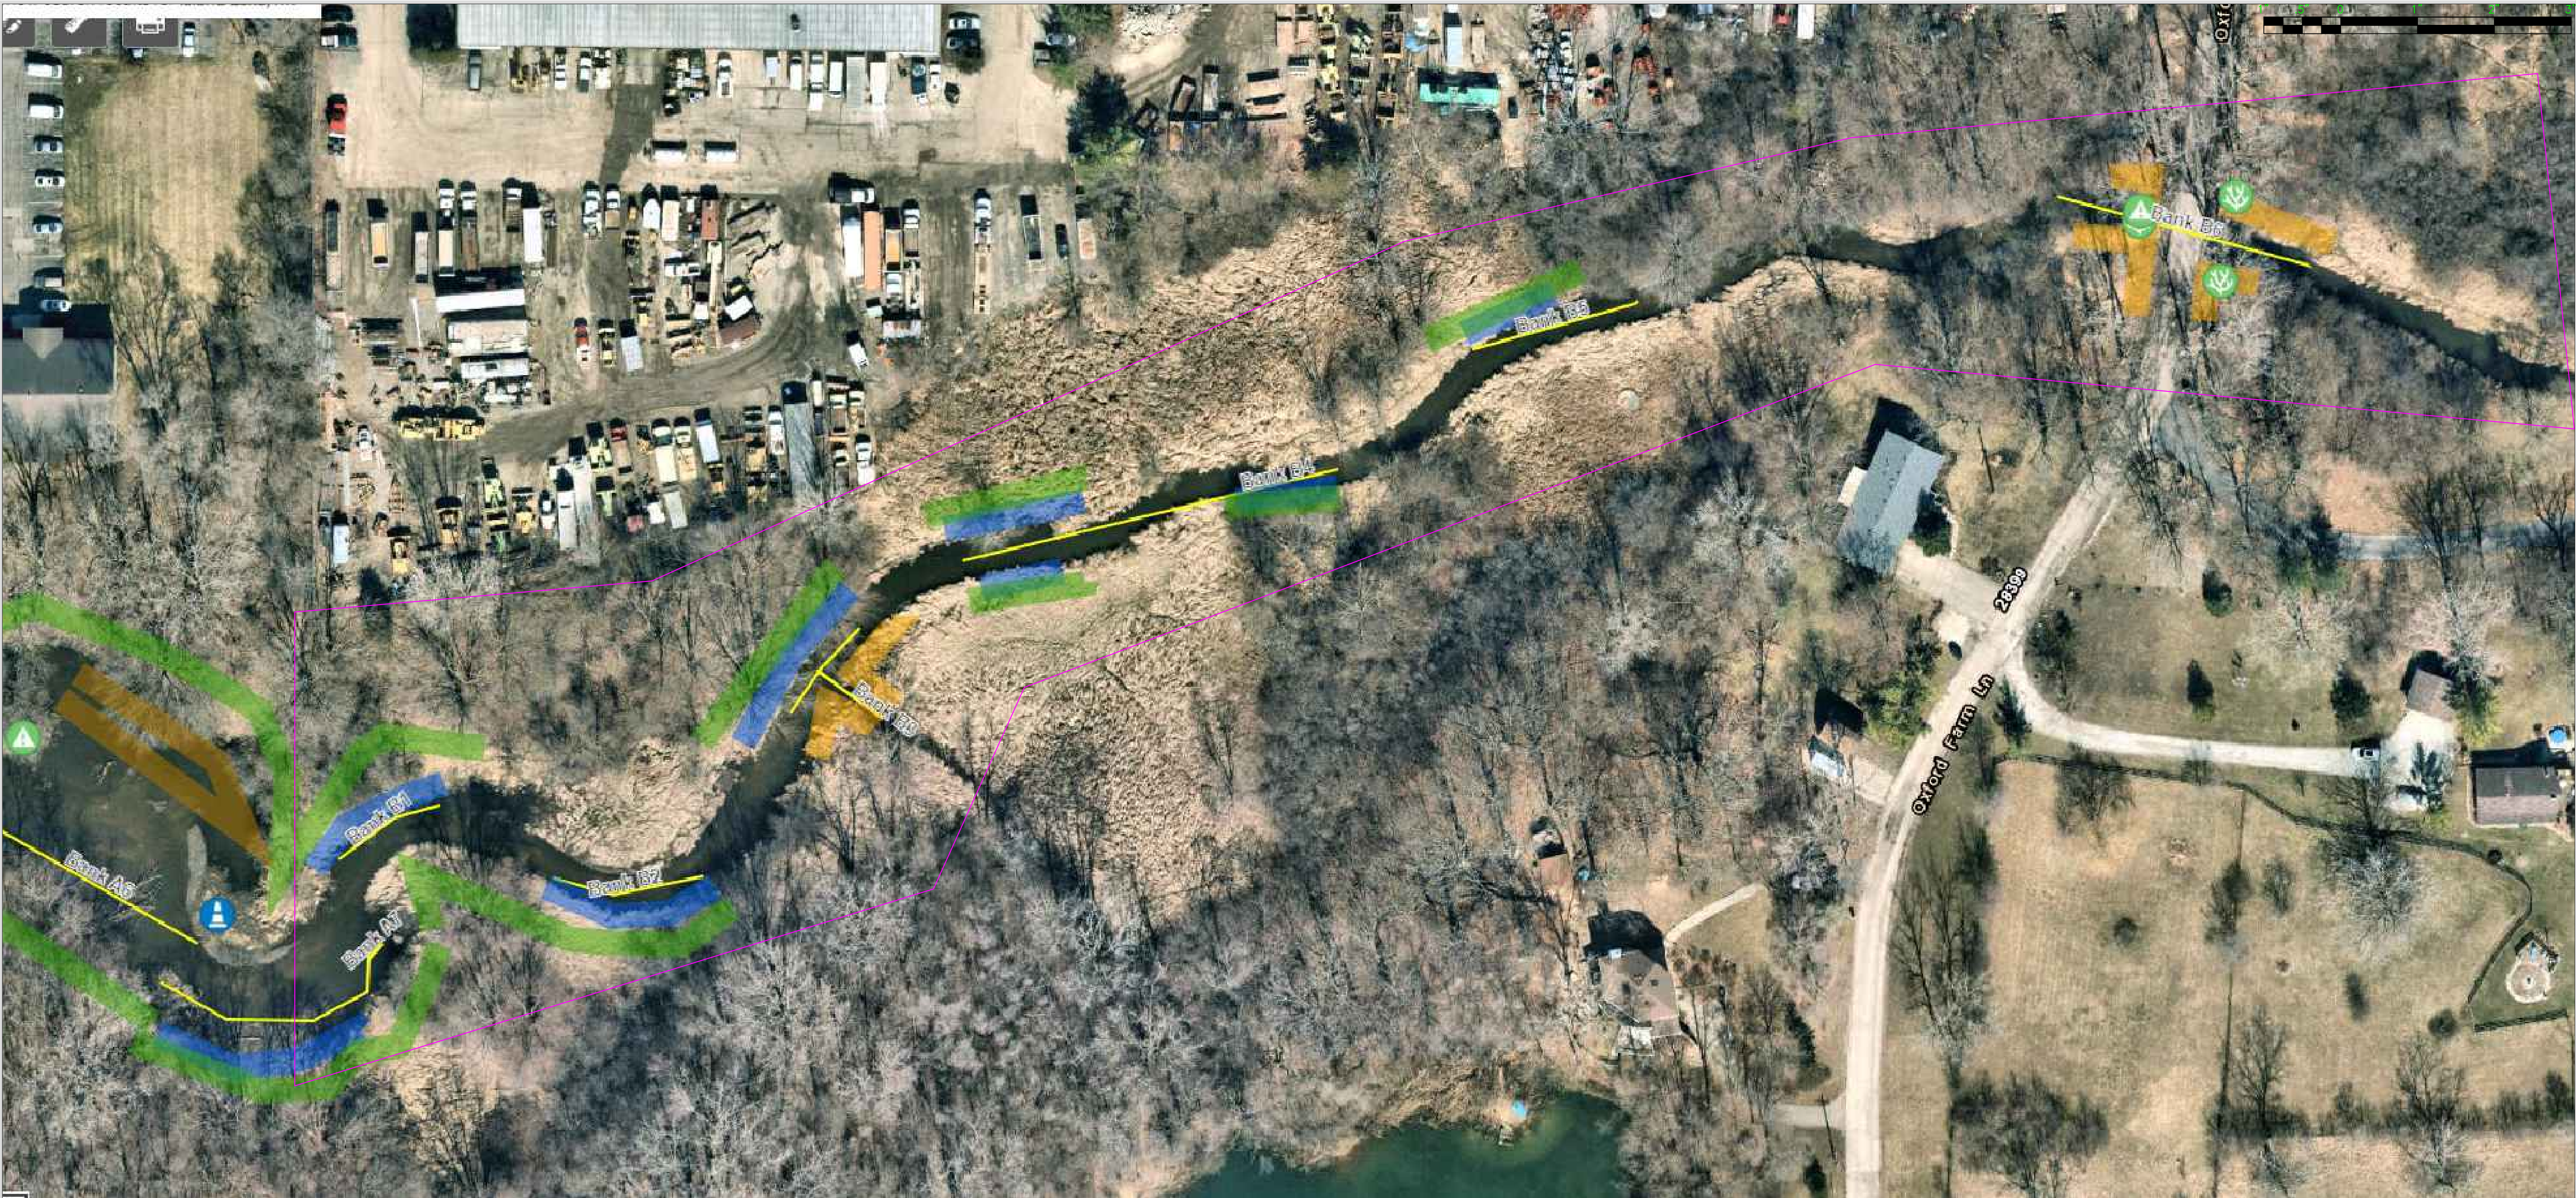
Exhibit B

Feet of Bank erosion
B1 = 60ft
B2 = 70ft
B3 = 80ft
B4 = 150ft
B5 = 80ft

After burning or mowing, construction work would start and consist of mostly reshaping with some regrading of the slopes. Some cross veins would be put in to direct the flow of the river, but large rock armaments should not be necessary for this section. Sediment removal will also need to be implemented to remove several inches of loose sediment that has settled in the slower parts of this section.

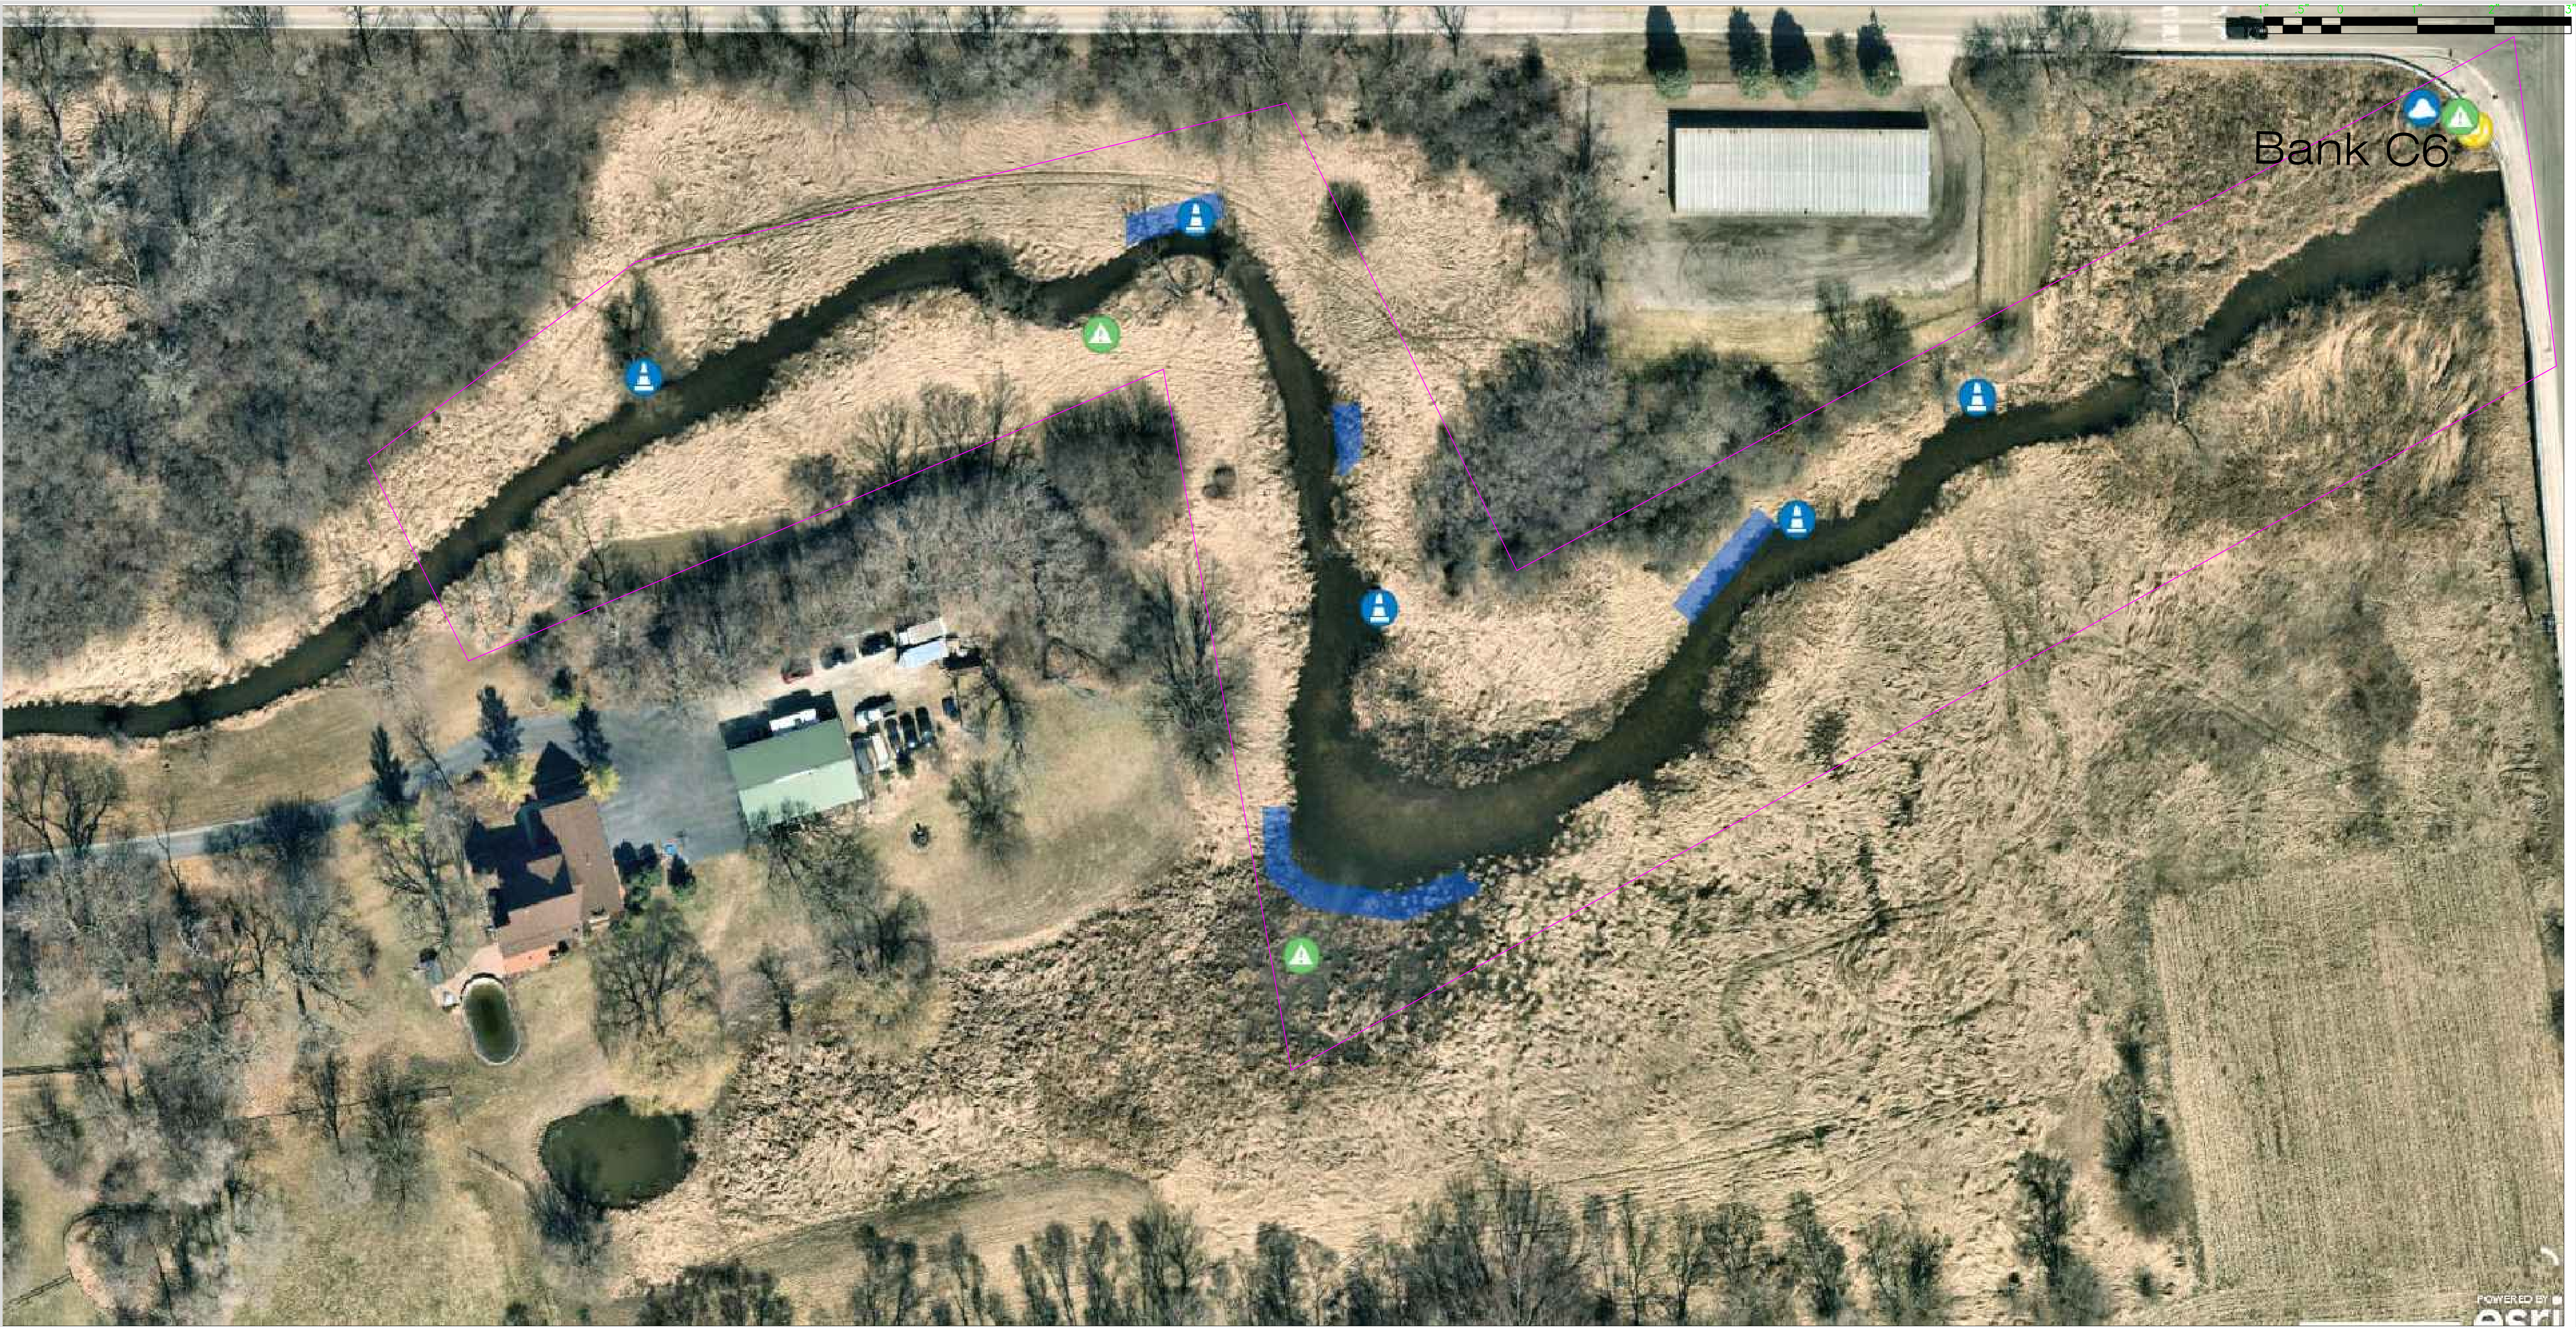
Exhibit C

Feet of Bank erosion
C6=40 ft

The construction in this section would be focused on the culvert at the east-most end of the project area. Recommended work here would be to repair the existing drainage area next to the culvert. This would be done by digging out the area to regrade, then reenforce with rock to allow better drainage.

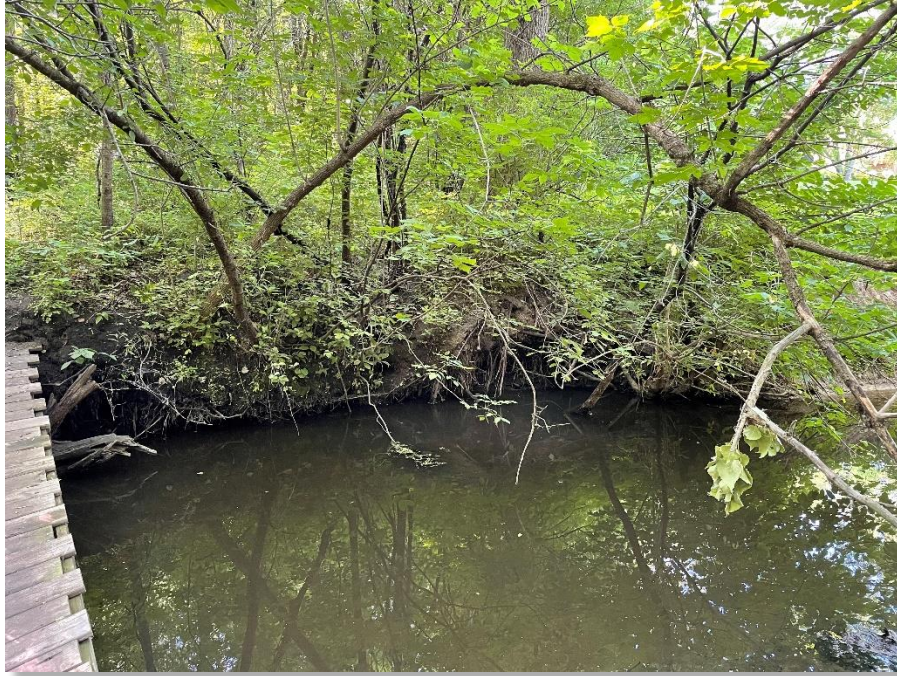
This Bank is located on the far west side of the creek and would be the start of the erosion work. A minimum of 20 feet of this section has erosion damage. Regrading and sediment removal would both be needed. This section has medium ground cover with a mix of scattered trees and shrubs containing both large and small trees. The edge of the bank shows erosion damage cutting along the base of a large tree with about 12 inches soil loss. Brush would need to be cleared prior to any work on this bank.

Photo 1. Bank A1.1

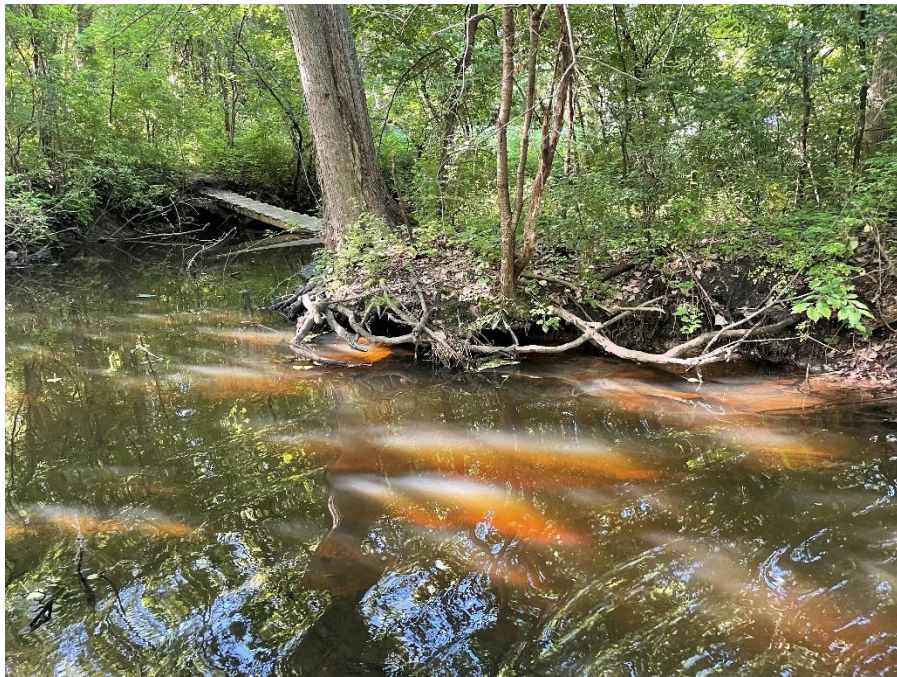
This section is adjacent to section A1.1, runs about 70 feet, and has fairly dense ground cover with scattered smaller honeysuckles. The bank shows about 60 feet of erosion with a drop of roughly three feet of soil height. Brush would need to be cleared before any work could be done and regrading and sediment removal would be needed. Brush would need to be cleared prior to any work on this bank.

Photo 2. Bank A1

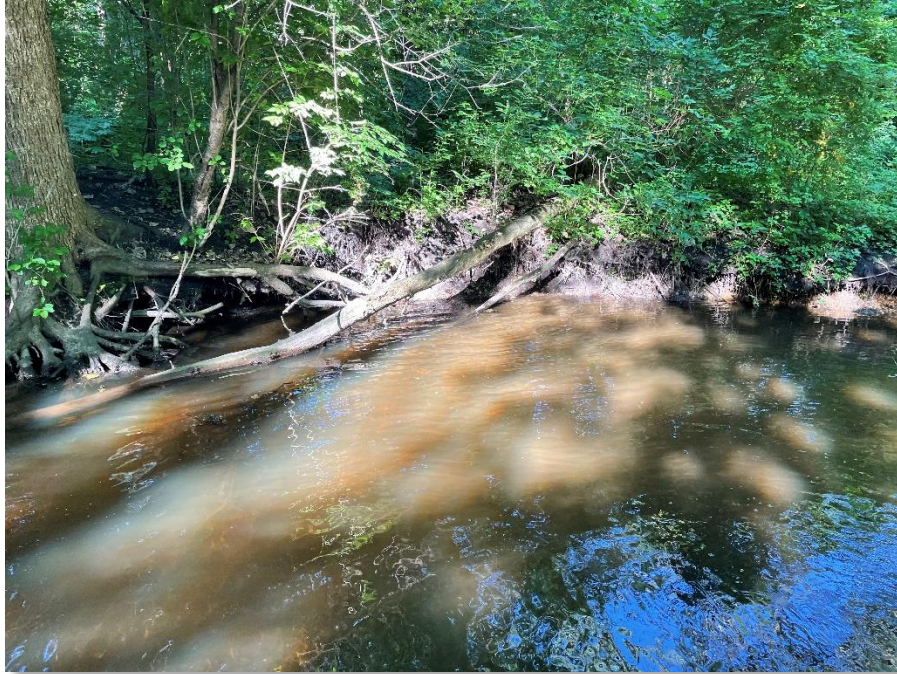
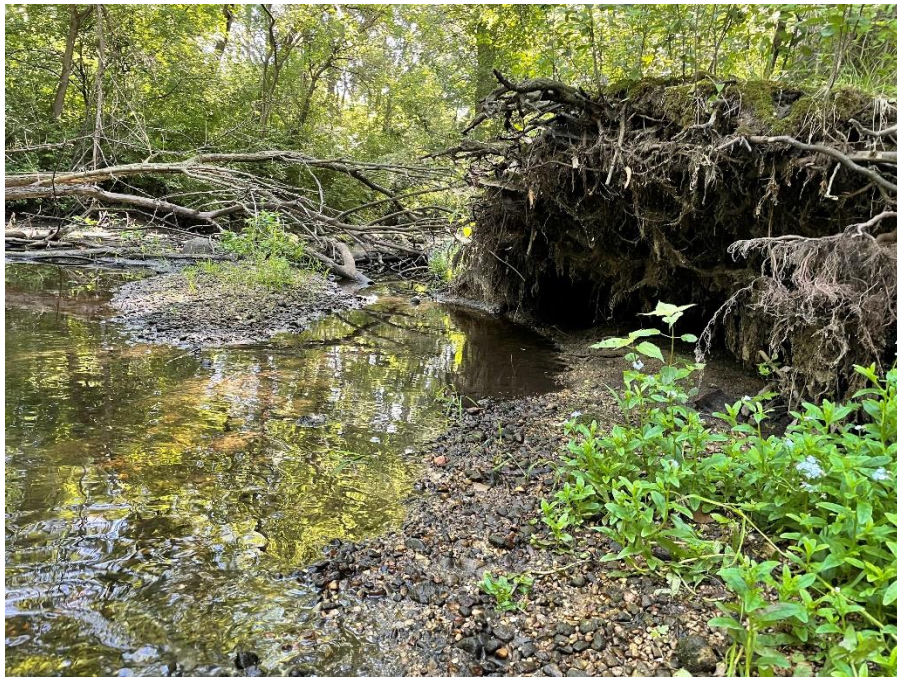
This section runs 80 feet and has dense ground cover with scattered small to medium trees and has a couple of large trees as well. This section has medium to high erosion and would need regrading and sediment removal. Brush would need to be cleared prior to any work on this bank.

Photo 3. Bank A2

Photo 4. Opposite side of Bank A2

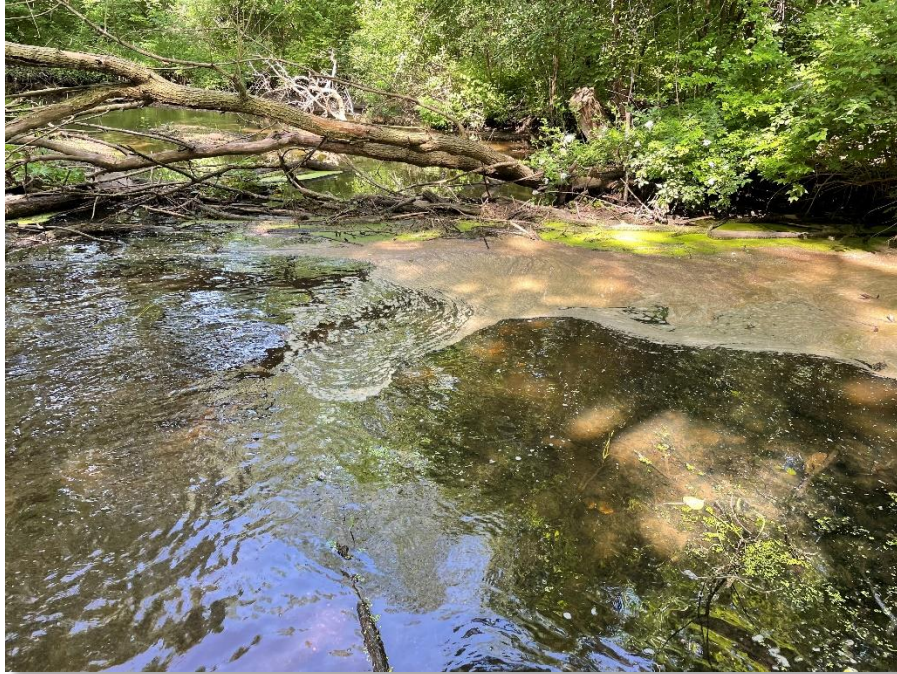
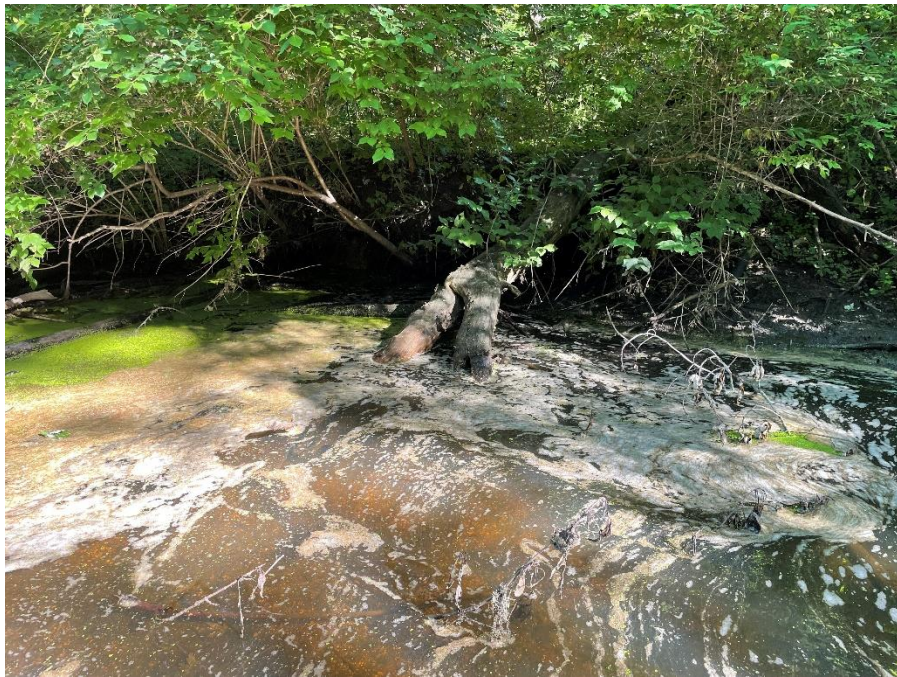
This section runs 40 feet and has dense ground cover as well as dense medium-sized brush. There is an obstruction of a fallen tree just before the bank creating a small dam. The bank has several feet of soil loss and would need much regrading and sediment removal. Brush would need to be cleared prior to any work on this bank.

Photo 5. Obstruction near Bank A3

Photo 6. Bank A3

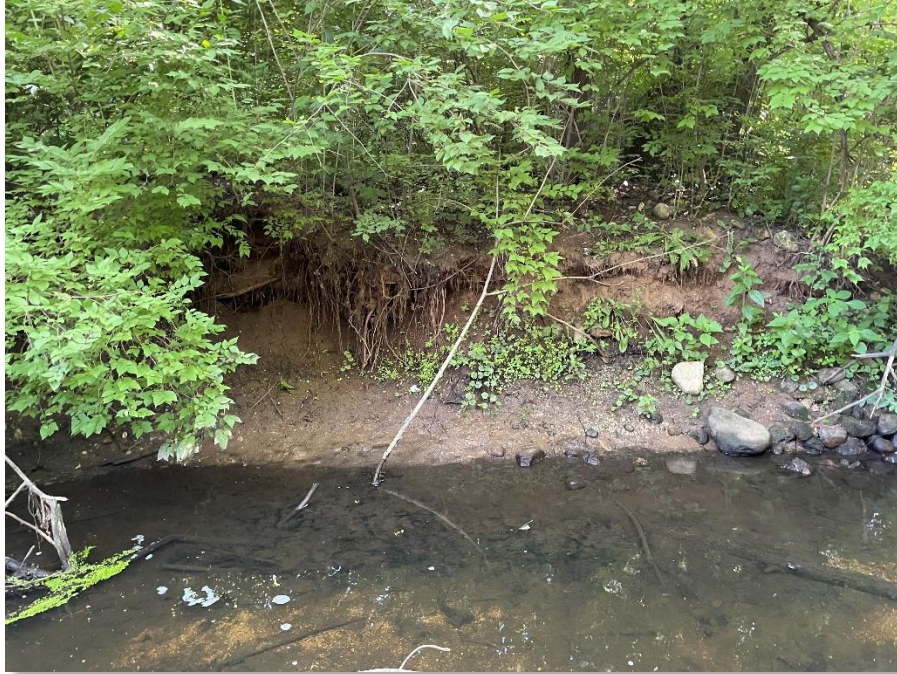
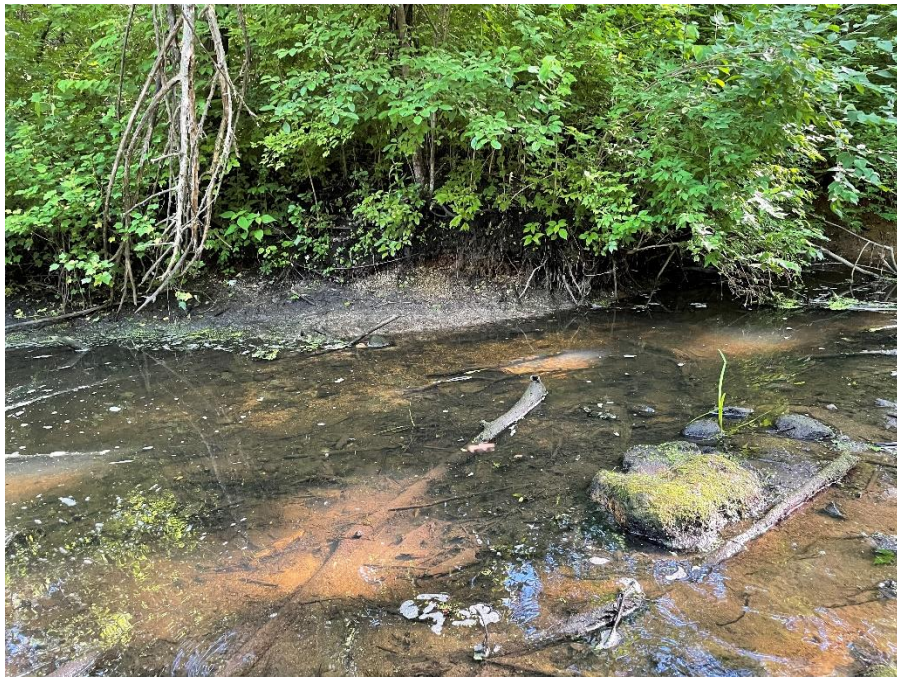
This section runs just past A3 and is 45 feet in length with dense ground cover as well as small trees. This section has significant soil loss with three to four feet of erosion at the bank. Heavy regrading and sediment removal would be needed. Brush would need to be cleared prior to any work on this bank.

Photo 7. Bank A4

Photo 8. Bank A4.1

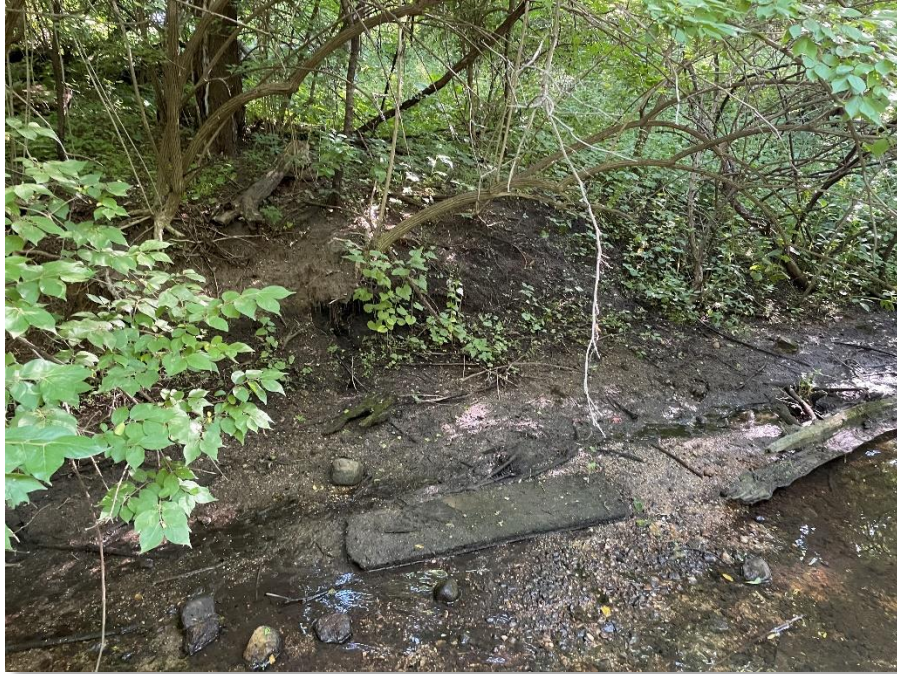
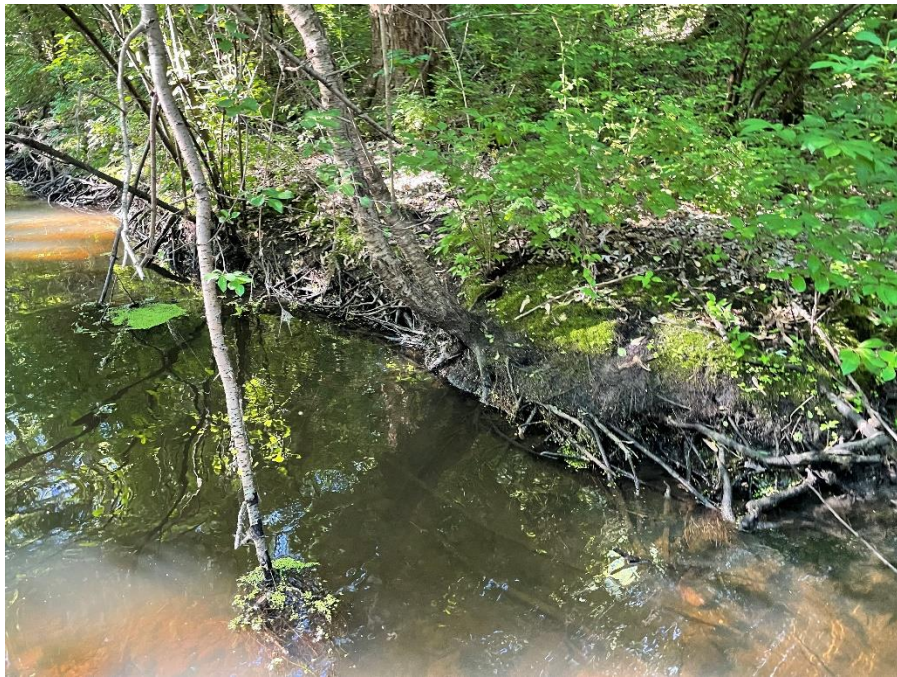
Photo 9. Bank A5

Photo 10. Bank A5.1

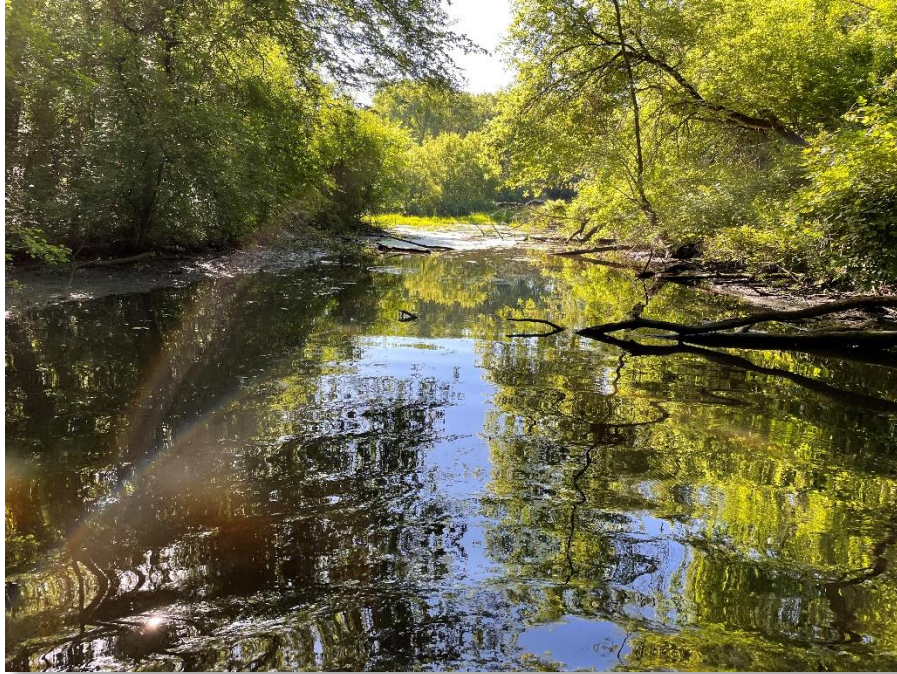
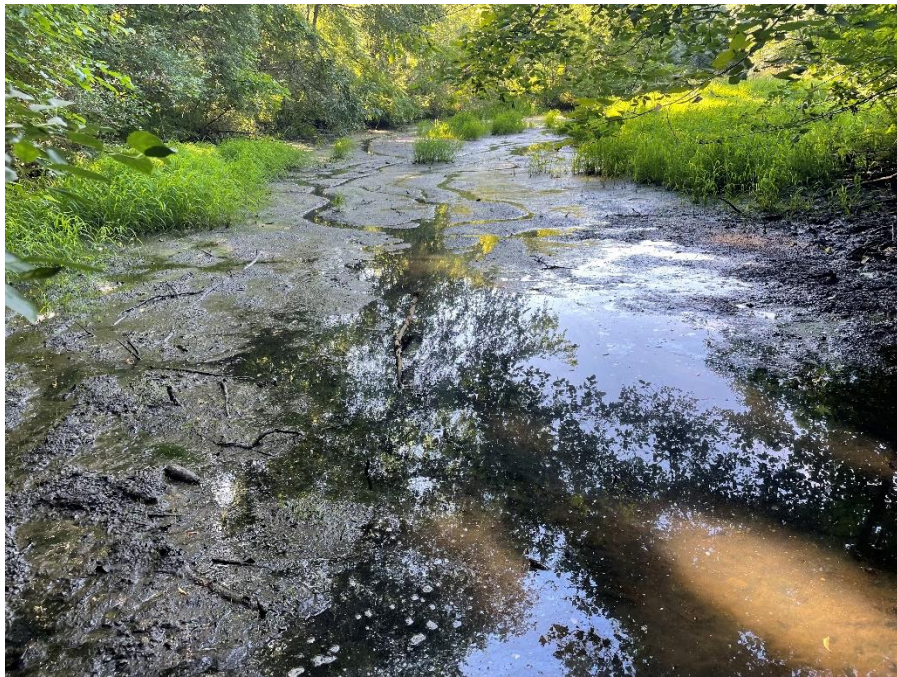
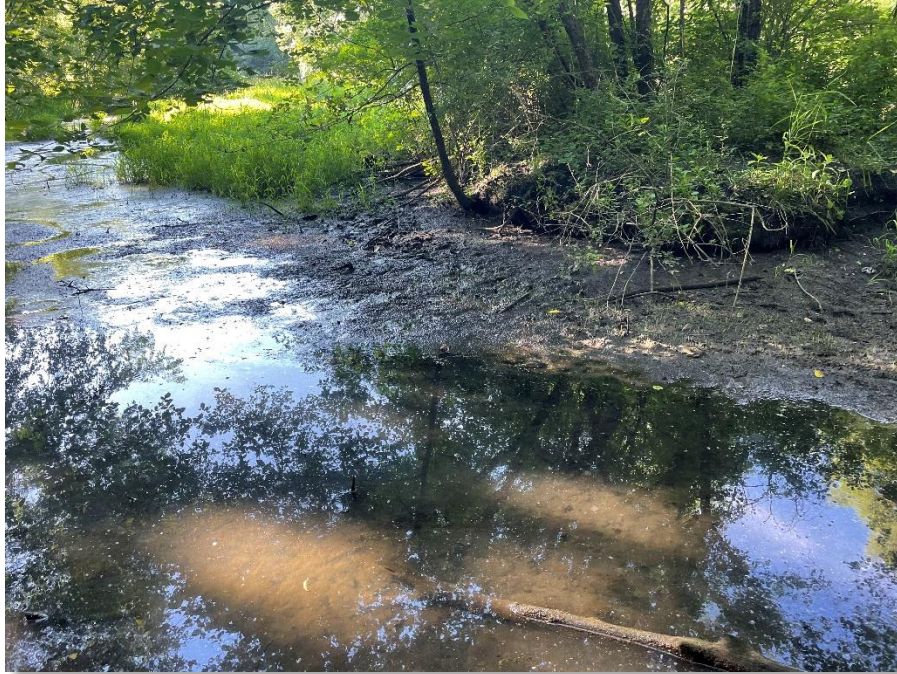
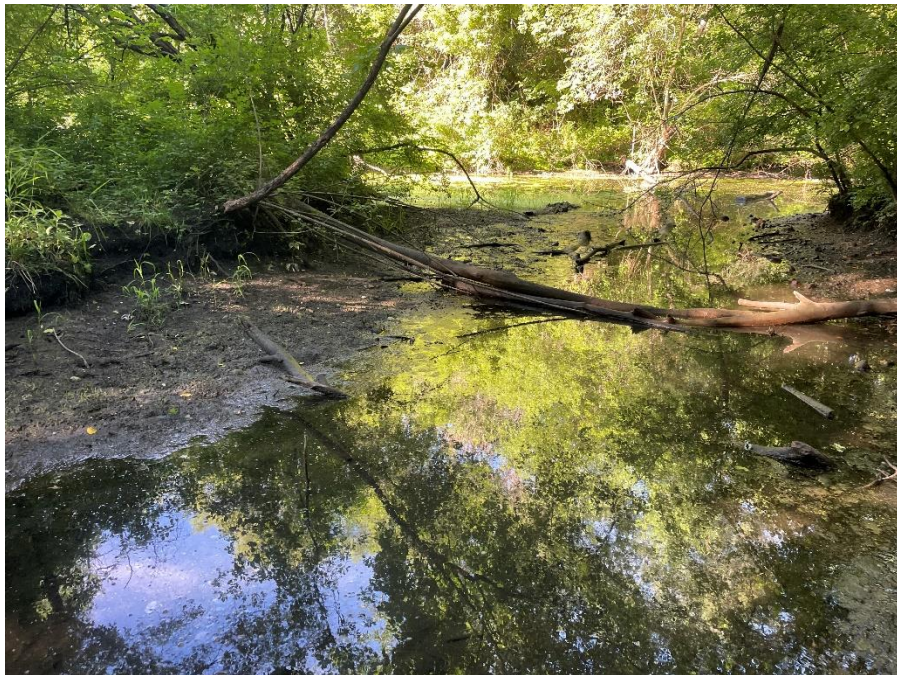
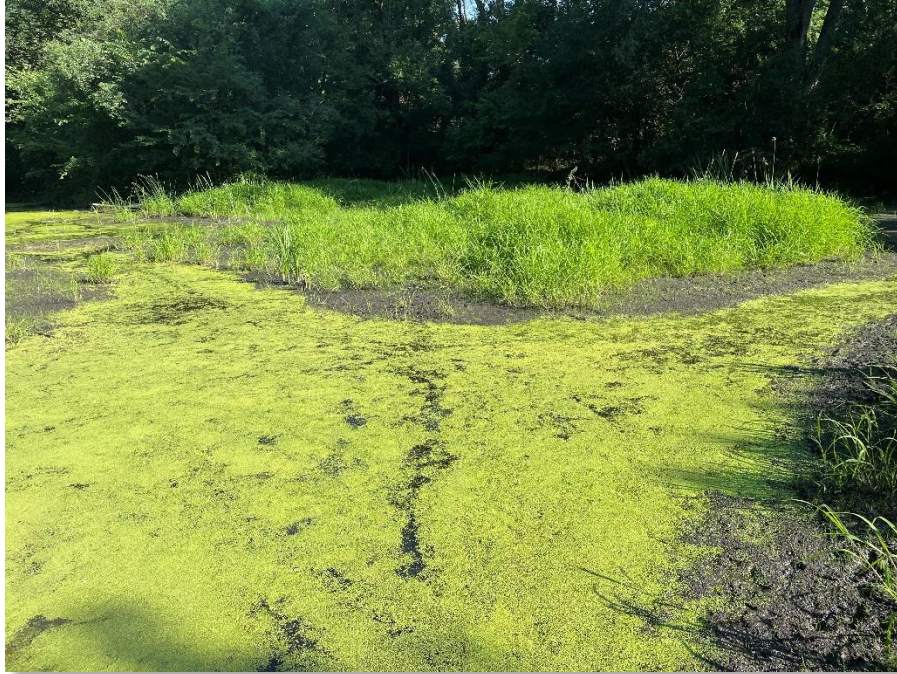
This section has some issues caused from back up of water most likely created from the bottlenecking of the creek near section A5.2. This area has turned into a small pond-like feature creating a small island as well as fishhook land structure. There are still pockets of sediment deposits that have been left where cattails and other wetland vegetation have grown. Brush would need to be cleared before any work can be done.

Photo 11. Looking southeast upstream towards Bank A6

Photo 12. Northwest side of Bank A6 looking east

Photo 13. Bank A6 looking south from the same point as Photo 12

Photo 14. Bank A6 looking southwest from same point as Photo 12

Photo 15. Taken from the fishhook land structure looking at the sediment deposit at Bank A6

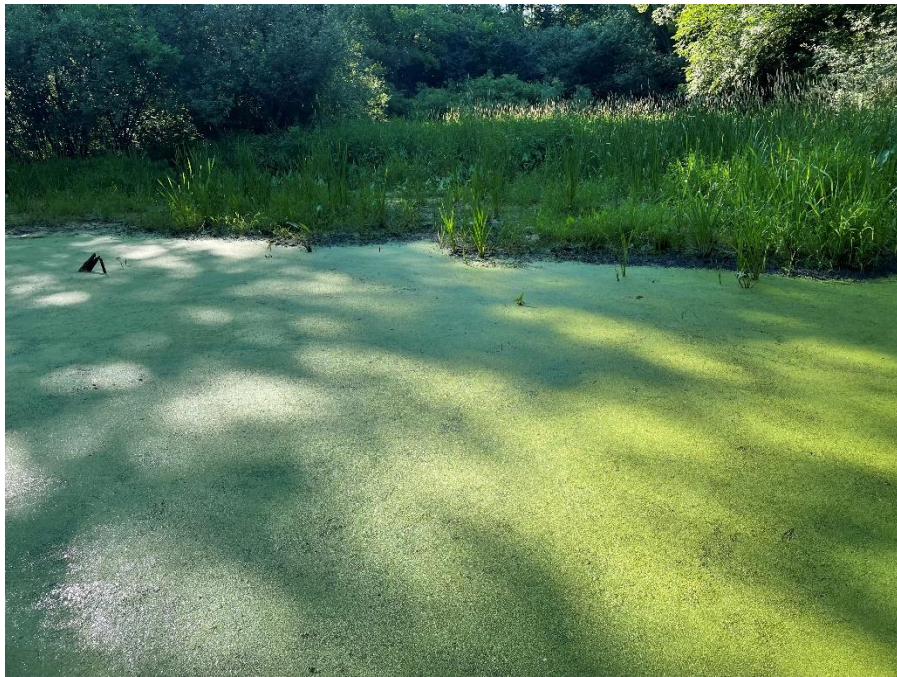
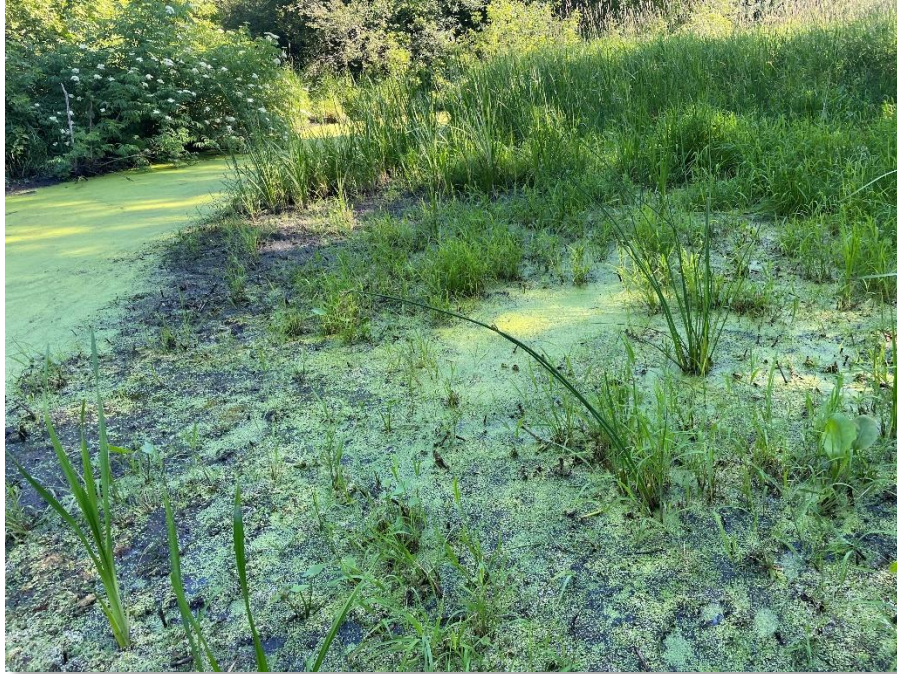
This section has some issues caused from back up of water most likely created from the bottlenecking of the creek near section A5.2. There are still pockets of sediment deposits that have been left where cattails and other wetland vegetation have grown. Brush would need to be cleared before any work can be done. There is also some erosion work that would need to be addressed on the South side of this bank. It has a mix of brush and wetland vegetation.

Photo 16. Bank A7 looking at the south side of the bank

Photo 17. Bank A7 looking at the northeast side of the bank

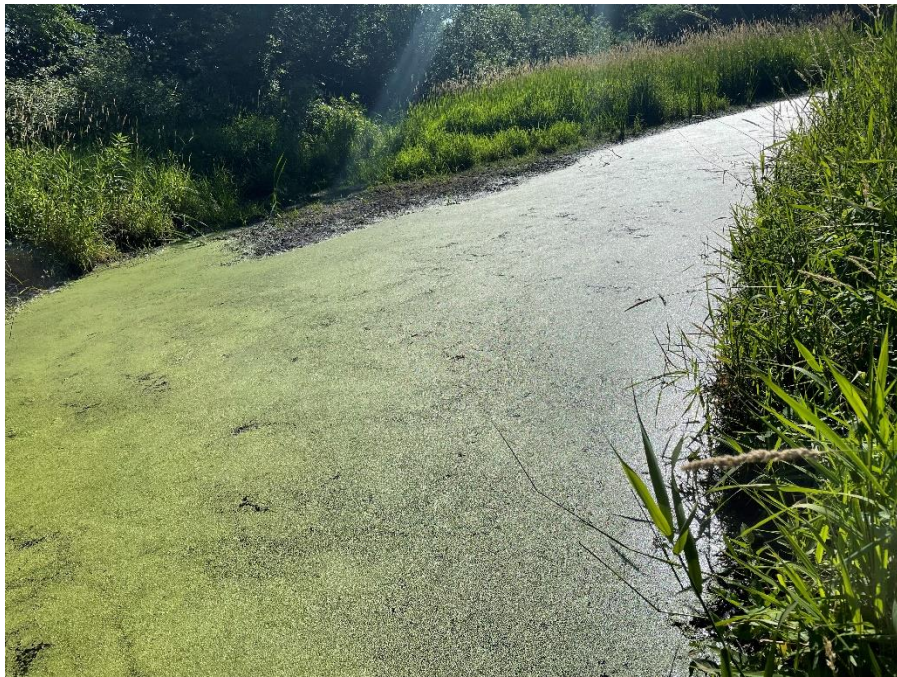
This section is made of almost entirely wetland vegetation such as cattails and phragmites and has a fair bit of erosion. Minimal brush clearing would need to be done and most of the work should be burning or mowing.

Photo 18. Bank B1 looking at the north side of the bank

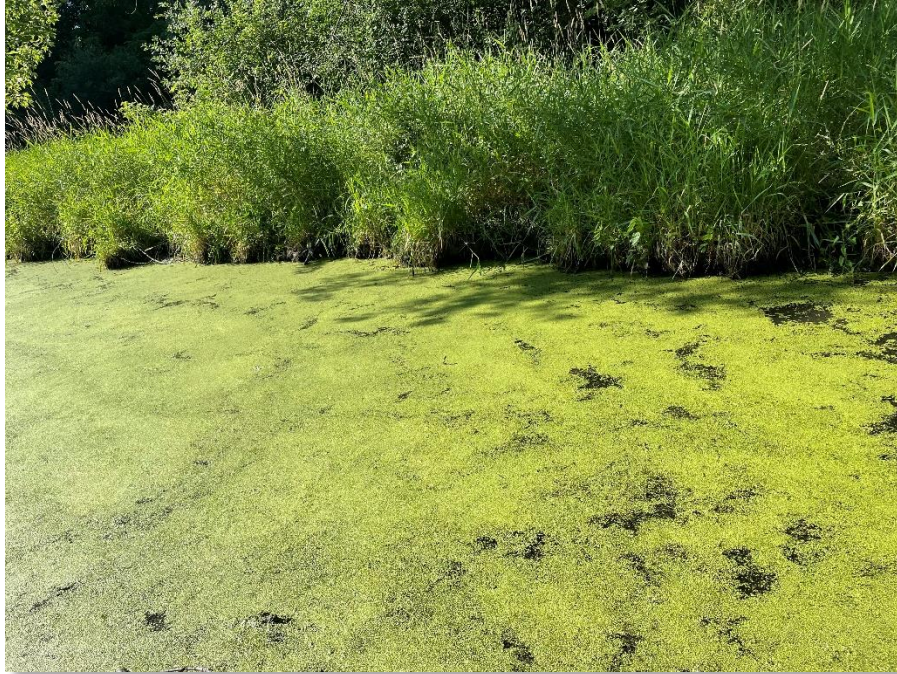
This section is made of almost entirely wetland vegetation such as cattails and phragmites and has a fair bit of erosion. Minimal brush clearing would need to be done and most of the work should be burning or mowing.

Photo 19. Bank B2 looking at the south side of the bank
