Village Creek Assessment Report

Village of Island Lake, Illinois

June 2022

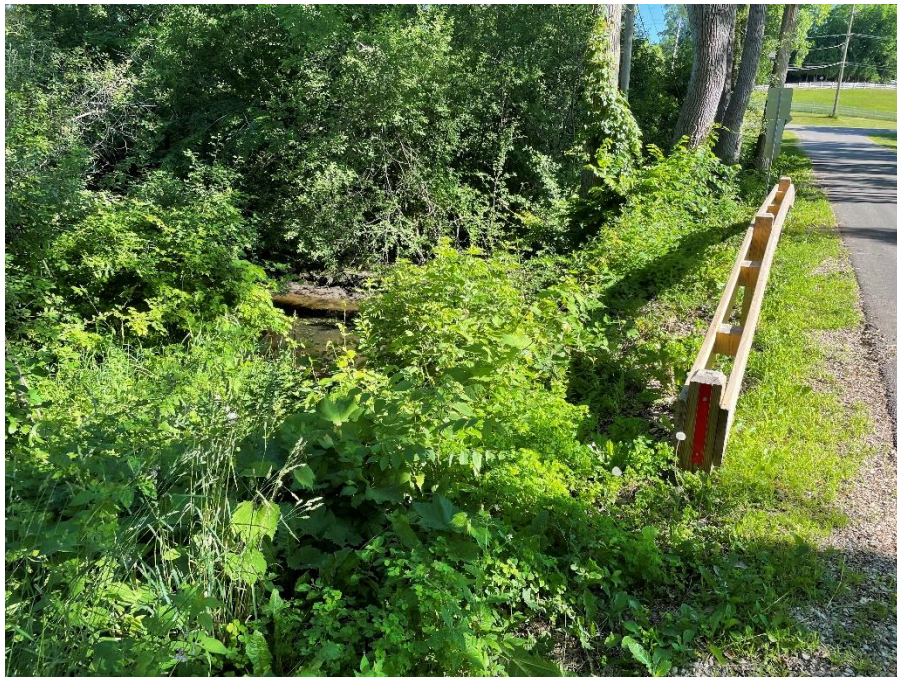
This section is just off of the Oxford Farms Lane where the creek intersects the road. The bridge that goes over the creek has nonnative vegetation growing. This would need to be cleared and replaced with native seed.

Photo 20. Bank B6 at the bridge looking at the west side

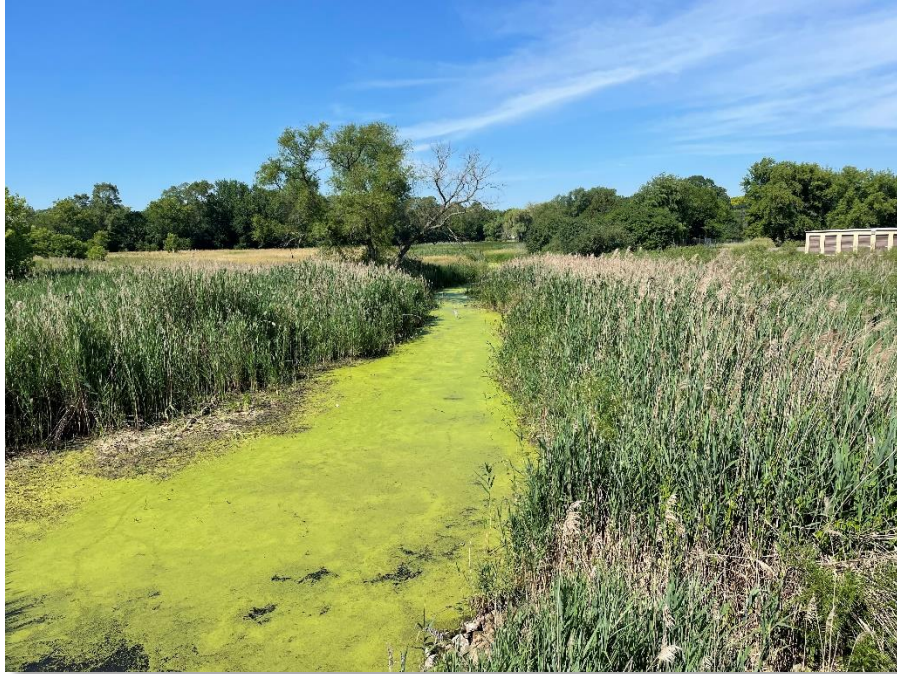
Photo 21. Taken from street overlooking most of Section C

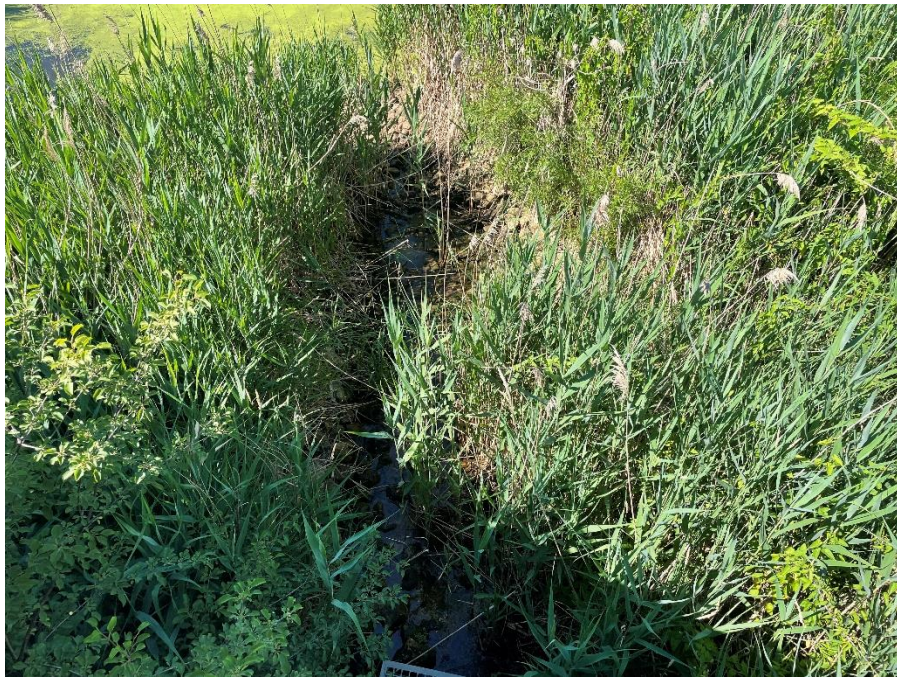
This section is at the very edge of the project boundary and has a rocky drainage area with thick wetland vegetation surrounding the area as well as a broken grate. A burn would take out most of the vegetation, but some brush work may need to be done.

Photo 22. Bank C6 looking at broken drainage grate

The construction in this section would be focused on the culvert at the east-most end of the project area. Recommended work here would be to repair the existing drainage area next to the culvert. This would be done by digging out the area to regrade, then reenforce with rock to allow better drainage.
